Manhole Inspection Summary

Manhole # S19KK_025MH

Insp Date: **6/6/07 8:54 AM**

Location Address: **1916 MONROE-PAYSON**

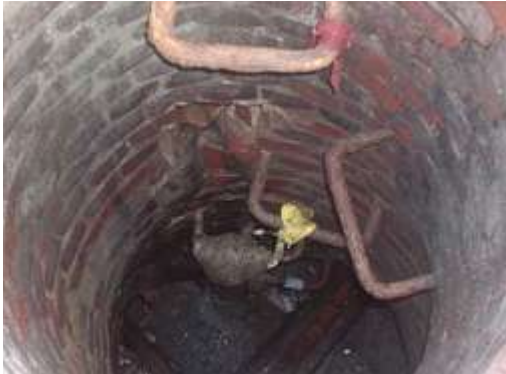
Defect 3

Infiltration: ☐ None ☐ Joint ☐ Cracks ☐ Mortar ☐ Roots ☒ **Wall**

Steps Count: **8** Missing: **0** ☒ **Corroded**

Surcharge ☒ **Evidence Of Surcharge** Depth: **6** (ft.) ☐ Active Surcharge Present

CORRODED STEPS, EVIDENCE OF SURCHARGE, AND INFILTRATION AT BARREL WALL

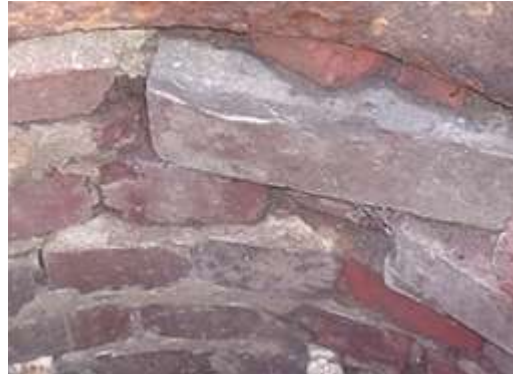
Defect 2

Condition: ☐ Sound ☐ Cracked ☐ Root Intrusion ☒ **Loose Brick** ☒ **Deteriorated**

LOOSE CHIMNEY BRICKS

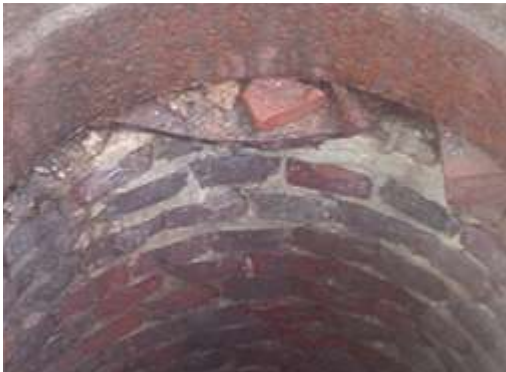
Defect 1

DETERIORATION OF CHIMNEY

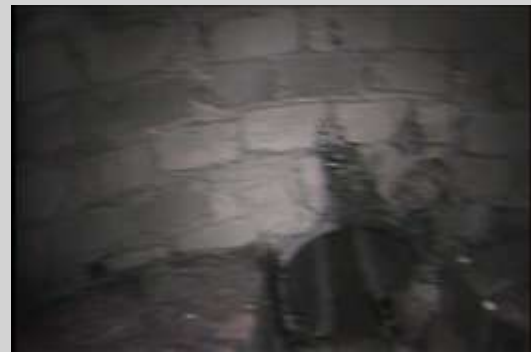
MAY BE BARREL INFILTRATION

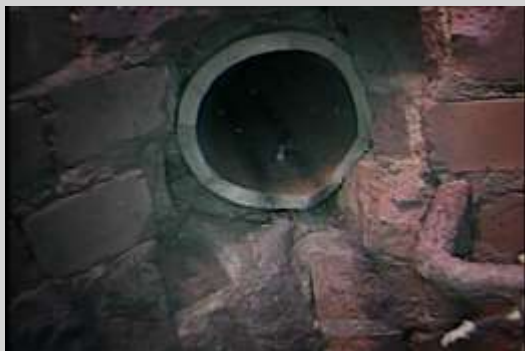
2 O'Clock Inflow

Pipe Height: **8.4** (in.) Rod and Bar (Angled)
Pipe Material: **Clay** ☐ Pipe Lined
Invert Depth: **7.20** (ft.) Flow Characteristics: **None**
Deposits: ☒ None ☐ Mud ☐ Sludge ☐ Debris ☐ Grease
Silt Depth: (in.) Deposits Extent:
Infiltration: **None** Pipe Seal Cond: **Broken**

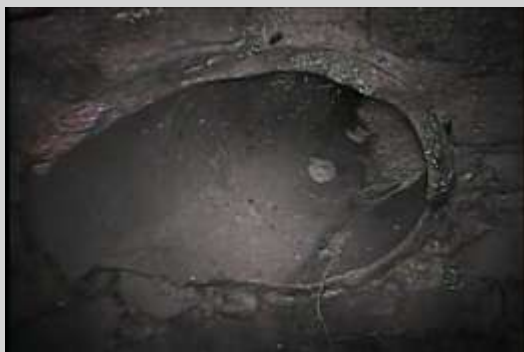
5 O'Clock Inflow

Infiltration: **None** Pipe Seal Cond: **Broken**
